# Manhole Inspection Summary

Manhole # S09EE1002MH

Insp Date: **6/27/07 3:17 PM**

**Location** Address: **3907 CALLAWAY AVE**

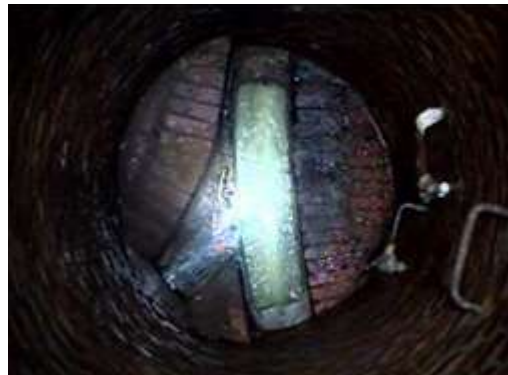
Defect 2

Count: **8** Missing: **0** ☒ **Corroded**

☒ **Evidence Of Surcharge** Depth: **4** (ft.) ☐ Active Surcharge Present

EVIDENCE SURCHARGE AND  
CORRODED STEPS

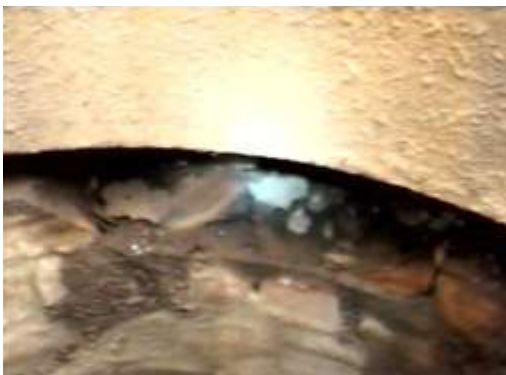
Defect 1

Condition: ☐ Sound ☐ Cracked ☐ Root Intrusion ☒ **Loose Brick** ☒ **Deteriorated**

LOOSE BRICKS AND DETERIOTATED  
CORBEL

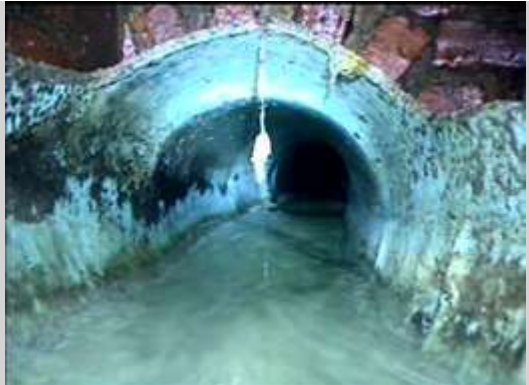
12 O'Clock Outflow

10 in. Circular Gravity Sewer  
Pipe Out @ 12 O'Clock

Pipe Height: (in.) Direct  
Pipe Material: **PVC** ☒ Pipe Lined  
Invert Depth: **14.15** (ft.) Flow Characteristics: **Fast**  
Deposits: ☒ None ☐ Mud ☐ Sludge ☐ Debris ☐ Grease  
Silt Depth: (in.) Deposits Extent:  
Infiltration: **None** Pipe Seal Cond: **Sound**

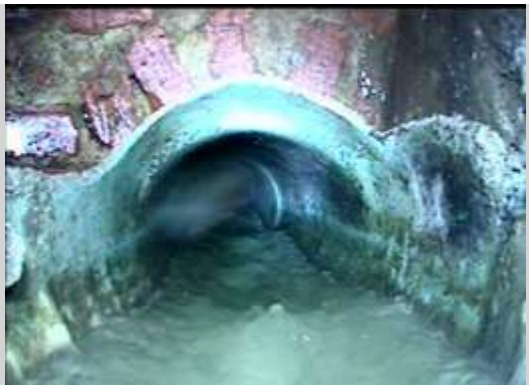
5 O'Clock Inflow

10 in. Circular Gravity Sewer  
Pipe In @ 5 O'Clock

Pipe Height: (in.) Direct  
Pipe Material: **PVC** ☒ Pipe Lined  
Invert Depth: **14.07** (ft.) Flow Characteristics: **Fast**  
Deposits: ☒ None ☐ Mud ☐ Sludge ☐ Debris ☐ Grease  
Silt Depth: (in.) Deposits Extent:  
Infiltration: **None** Pipe Seal Cond: **Sound**

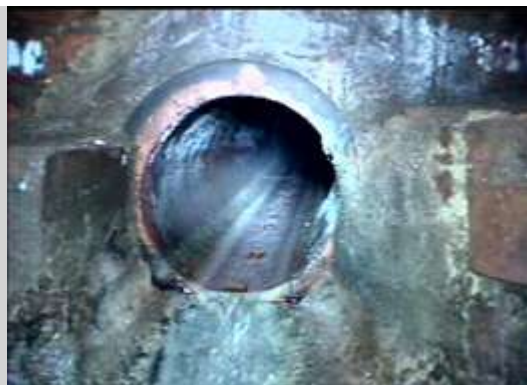
8 O'Clock Inflow

8 in. Circular Gravity Sewer  
Pipe In @ 8 O'Clock

Pipe Material: **Clay** ☐ Pipe Lined

Invert Depth: **13.30** (ft.) Flow Characteristics: **Slow**

Pipe Seal Cond: **Sound**
